May 24, 2011

Subject: Field Inspection and Analytical Results for the
DS Tributary Sediment Sampling
Detrex Corporation, Ashtabula, Ohio
Docket No. V-W-98-C-450

PHOTOGRAPHIC LOG

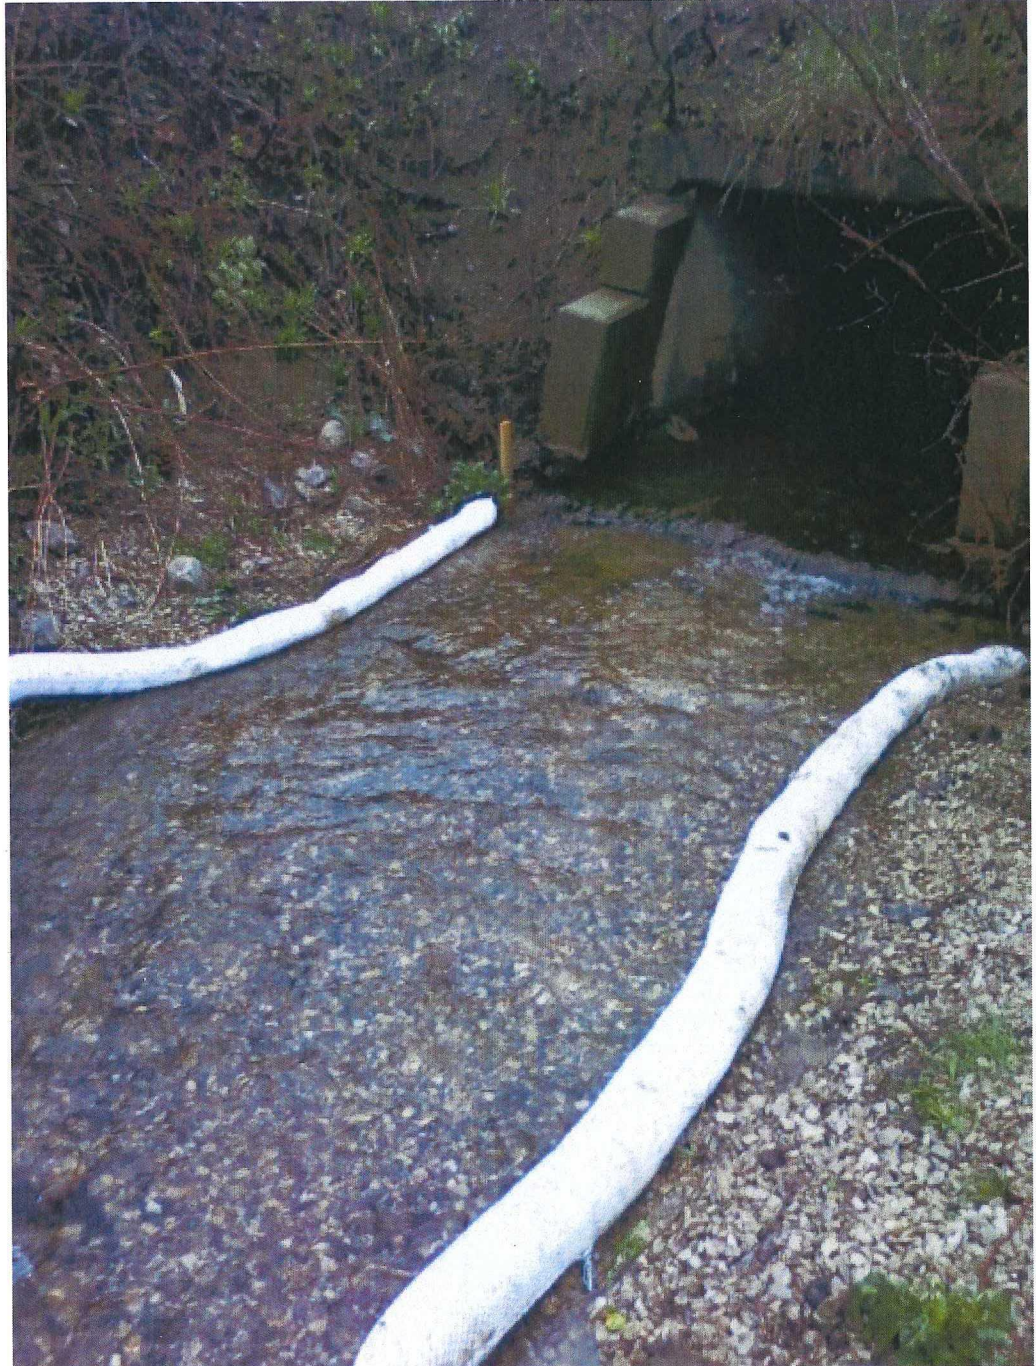
Photo No.
1

Photo looking east.
Sample location Sed-2
taken directly in front of
culvert concrete lip.
Note: booms were installed
by Detrex Corporation.

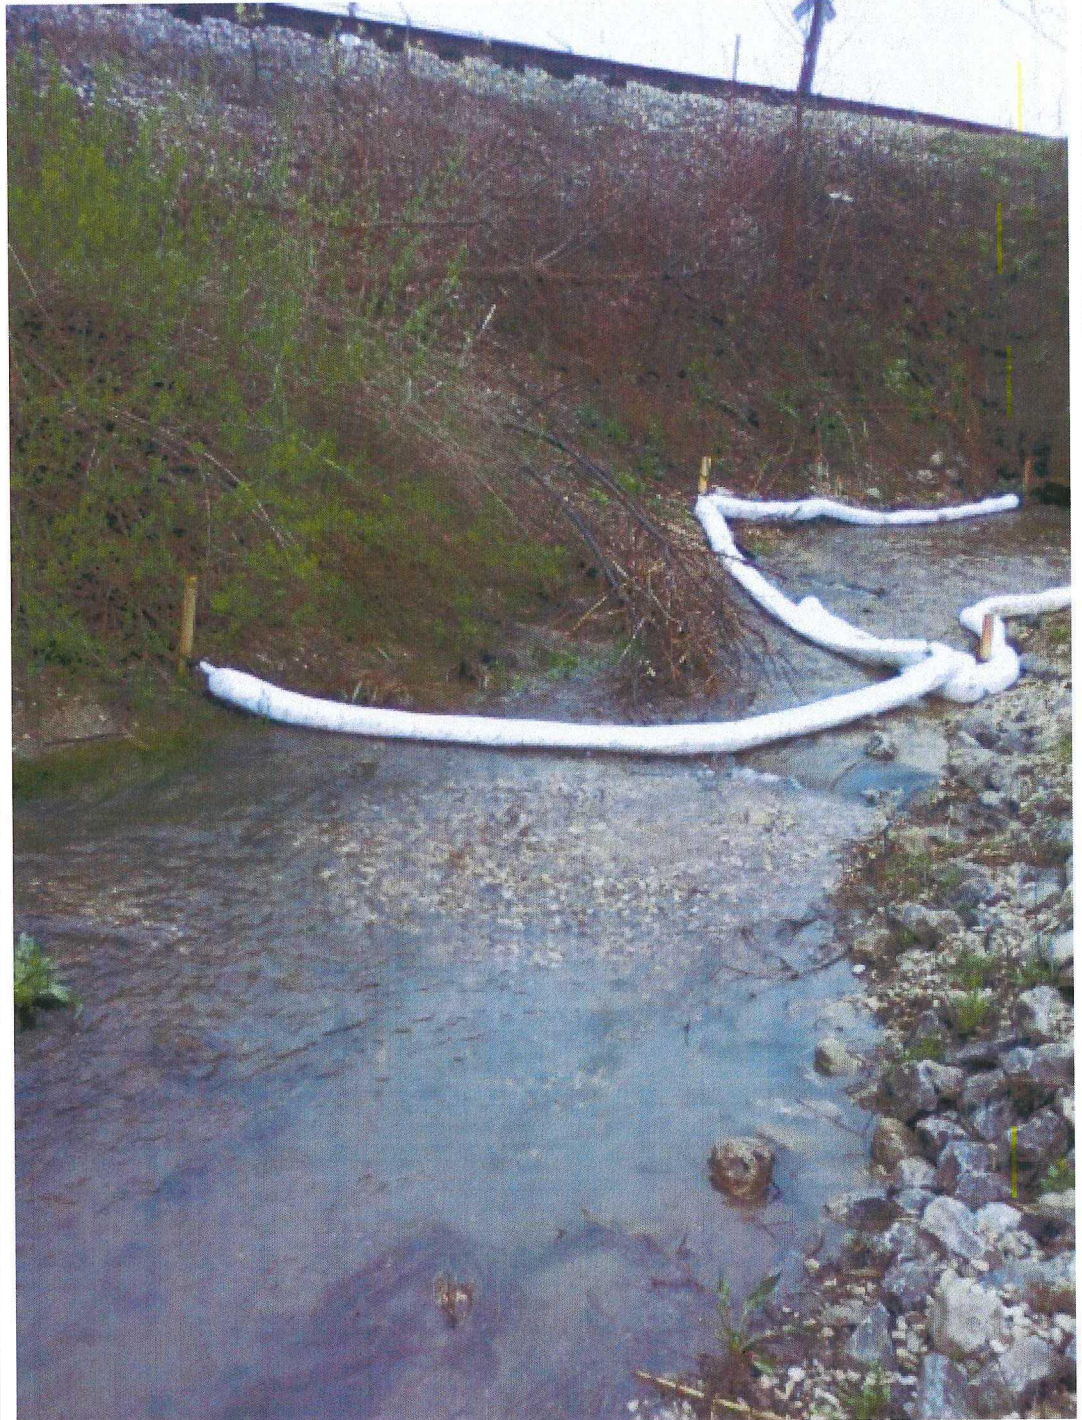
Photo No.
2

Photo looking northeast.
Sample Sed-5 was taken in
the middle of the DS
Tributary channel
downstream of the first
collection trench (Trench-1)
Note: booms were installed
by Detrex Corporation.

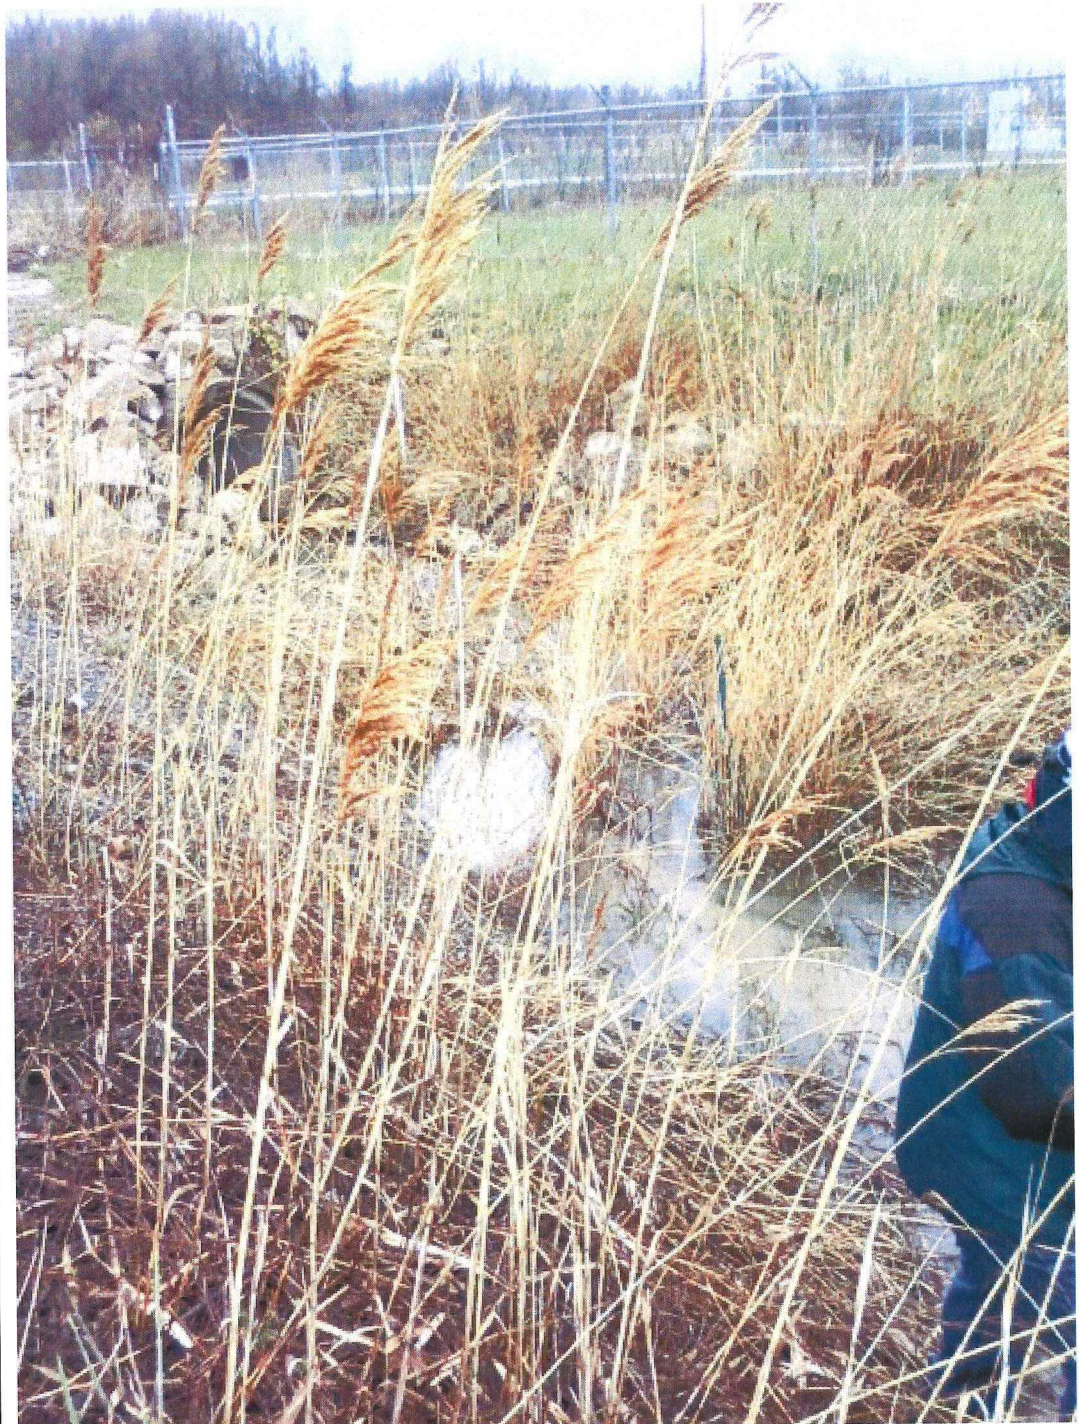
Photo No.
3

Photo looking northwest, samples Sed-7 (up) and Sed (8) within the DS tributary channel, Sed-9 (up) is not pictured. Note the round concrete culvert east of State Road.
